Final Project Report

Project title	Further development of a dolphin exclusion device		
DEFRA project code	MF0735		
Contractor organisation and location	Sea Mammal Research Unit Gatty Marine Laboratory University of St Andrews St Andrews, Fife KY16 8LB		
Total DEFRA project costs	£ 87,059.55		
Project start date	25/11/02	Project end date	31/3/2003

Further development of a dolphin exclusion device

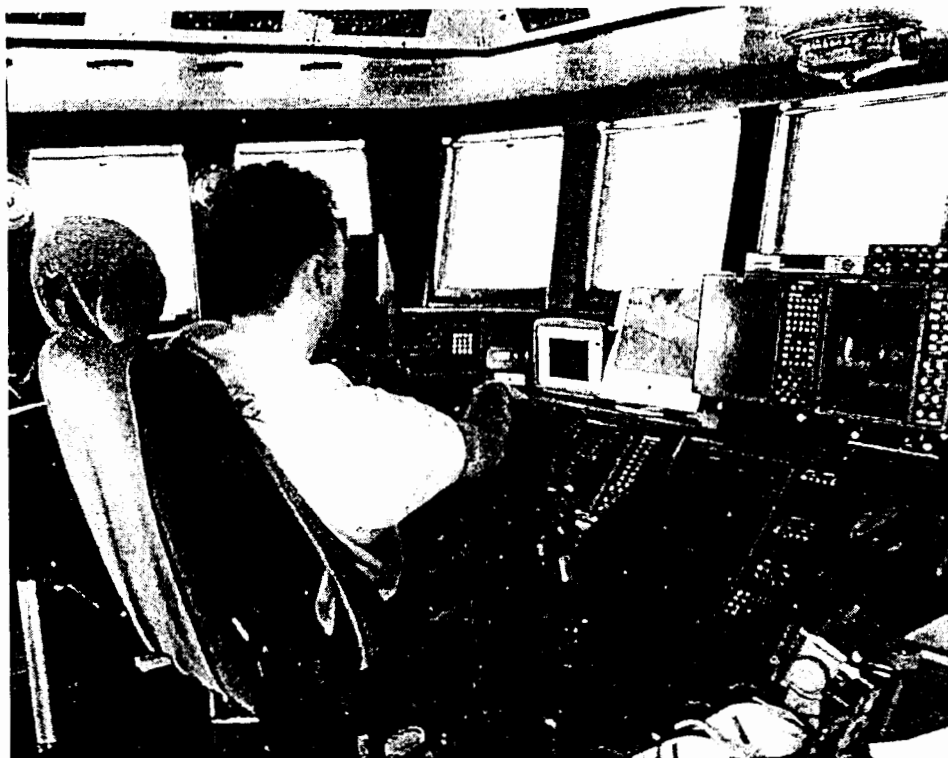
Figure 2: The wheelhouse: continuous monitoring of the grid was possible using a large flatscreen display

To address the issue of a twin camera monitoring system we contracted Prove Sytems (Philippe Hubert) in Tayport, a company with many years of specialist work in subsea monitoring with the oil industry, to help design and develop a suitable camera and lighting system. To this end we hired a 900m Rochester armoured cable with twin coaxial and power supply lines. We also hired two Kongsberg Simrad OE1324 SIT Low Light cameras. Prove systems supplied their own high-powered LED light sources. We used two SVHS Sony Video tape decks and two monitors in the wheelhouse to monitor and record the tow views of the net onto 4 hour SVHS tapes. Much of the time, we also diverted the signal from the interior net camera to a 17" flat-screen monitor in the wheelhouse to make visual monitoring easier (Figure 2).
